Client

Catt County Land Bank
215 S Barry
Olean, NY 14760
HIN™: 147602464
Email:
Inspection Date: 08-27-2020

Eagle Eye Home Inspectors, LLC
Shawn Wing
1523 OLEAN PORTVILLE RD
OLEAN, NY 14760
Phone: (716) 307-0514
E-Mail: info@eehomeinspectors.com

Welcome and thank you for choosing Eagle Eye Home Inspectors. This report is designed to be as thorough as possible, but also clear and concise. This is not a mold inspection. This is not a code inspection. If you have any questions please call us at (716) 307-0514 or (716) 378-8855

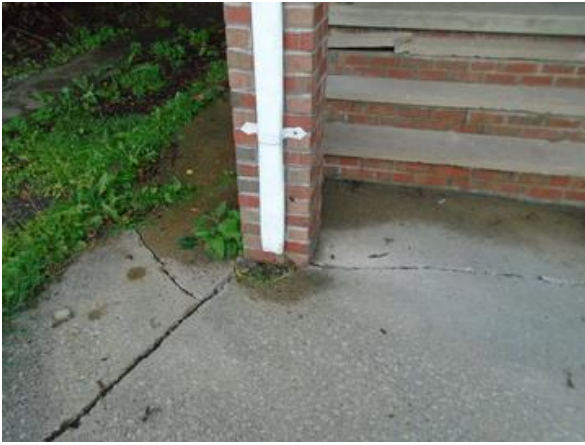
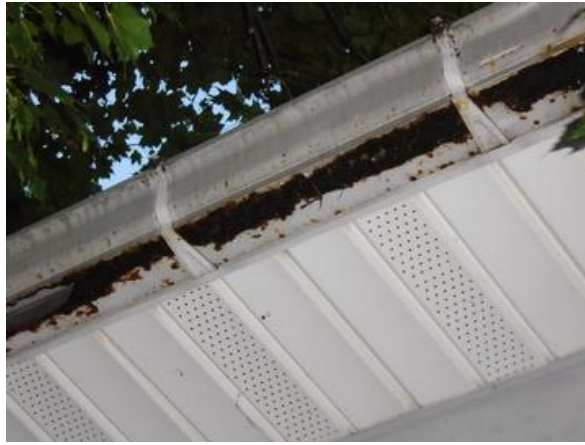
08/29/2020 Gutters are installed but are not functioning due to being broken, sagging, filled with debris, and having improper pitch. Proper functioning gutters are essential to keeping water away from the foundation to prevent water infiltration into the home. Recommend a qualified contractor replace gutters, downspouts, and extensions that are at least 6 ft. away from foundation wall.

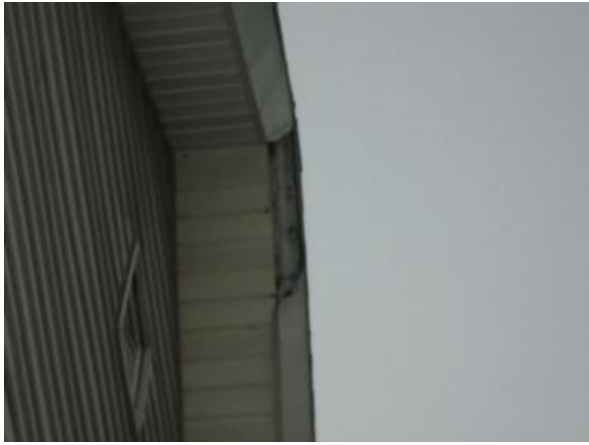
Sections of the fascia are missing or not securely attached. This metal is meant to protect the wood it covers from water, insects or vermin from damaging the wood. Recommend repair or replace as necessary.

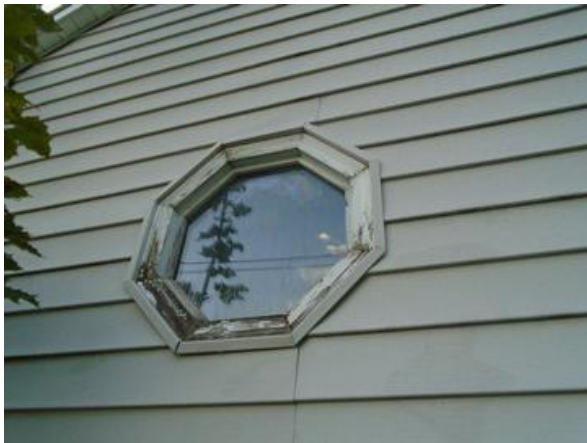
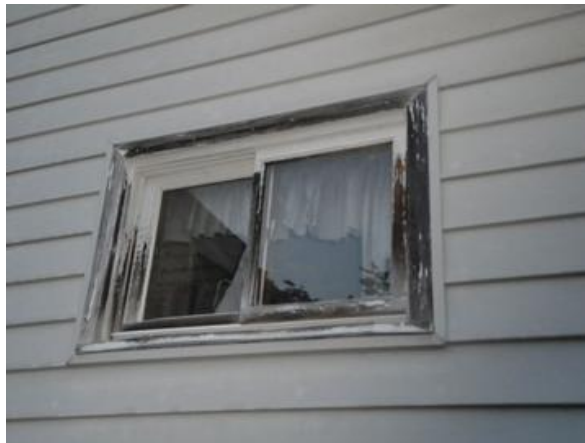
08/29/2020 Wood trim shows signs of deterioration. This could allow water intrusion within the structure resulting in further damage. Recommend licensed contractor repair and repaint as needed.

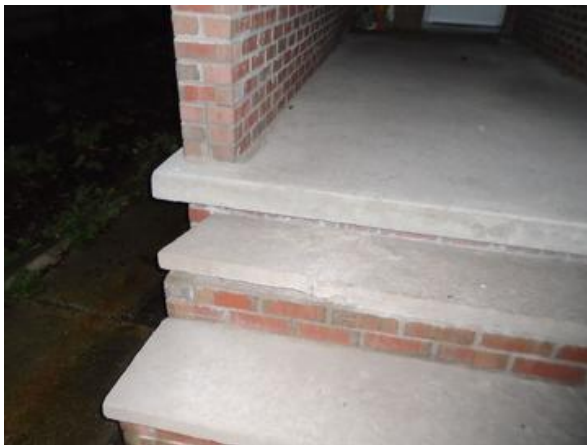
08/29/2020 Deteriorated concrete steps. Front steps pose a trip hazard. Recommend qualified contractor fix and repair as necessary.

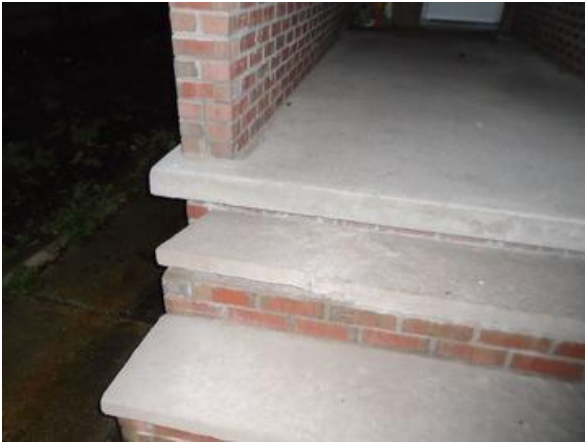
08/29/2020 Hand rail is missing on steps. This is a safety hazard. Recommend a qualified contractor repair as necessary.

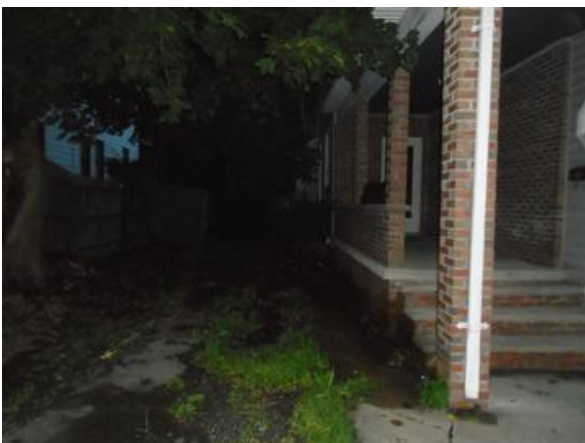
08/29/2020 Asphalt driveway in poor condition and needs to be replaced. Recommend a qualified contractor repair as necessary.

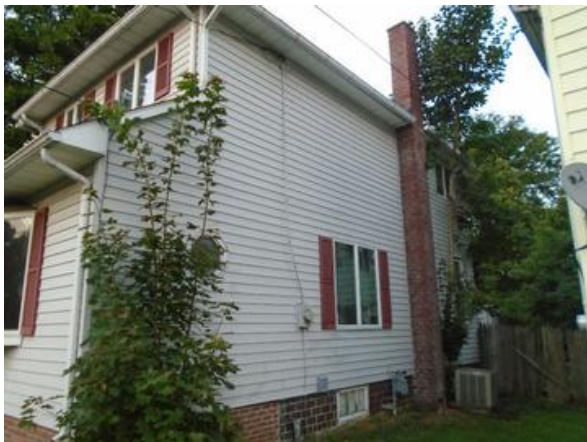
08/29/2020 Trees and shrubs are in contact with siding and overhanging roof. This allows the shrubs to rub against the house creating friction damage as well as not allowing the siding and roof to dry quickly after rain fall. This can also be a conduit for vermin and insects accessing the home. Recommend pruning or moving trees and shrubs so there's at least a one foot gap between shrubs and siding no no trees overhanging roof.

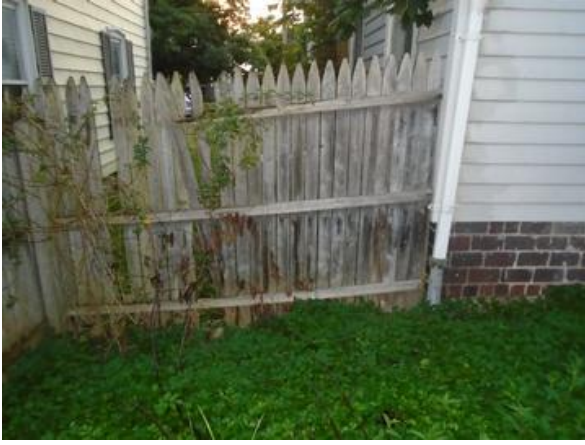
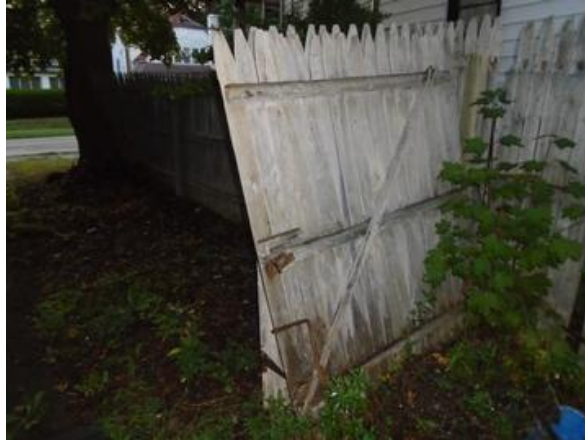
08/29/2020 Fence around property is in poor condition and needs replacing. Recommend qualified contractor evaluate and repair or replace where needed.

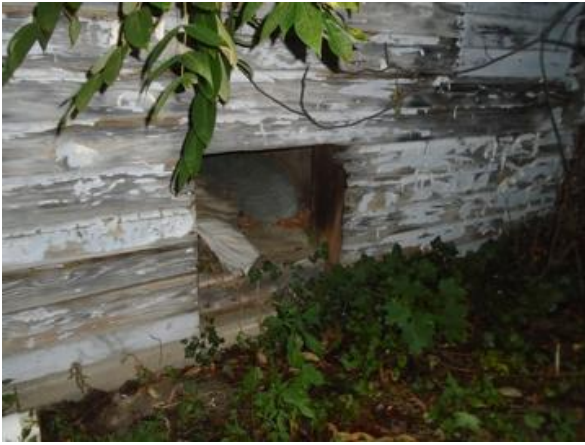
08/29/2020 Garage siding is damaged or deteriorated in 1 or more locations. This will allow water, insect and vermin intrusion. Recommend licensed contractor evaluate and repair as needed.

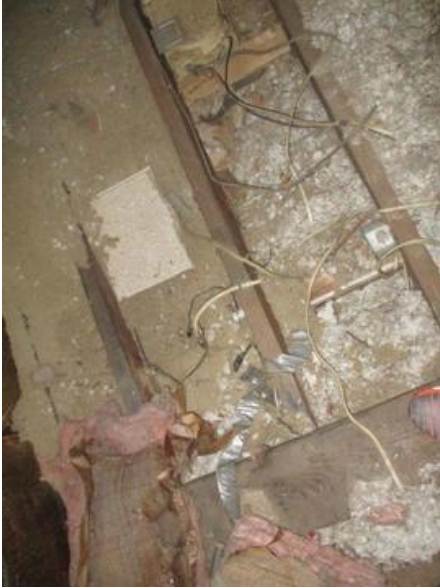
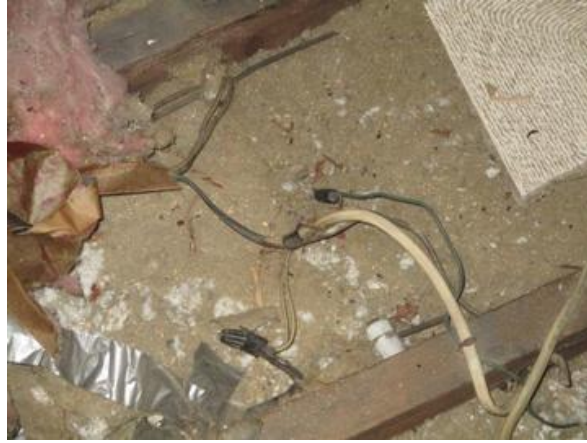
Exposed wiring due to splices not being contained in junction box. This could result in a fire. Recommend having a licensed electrician install junction boxes with cover plates where needed to contain wiring splices.

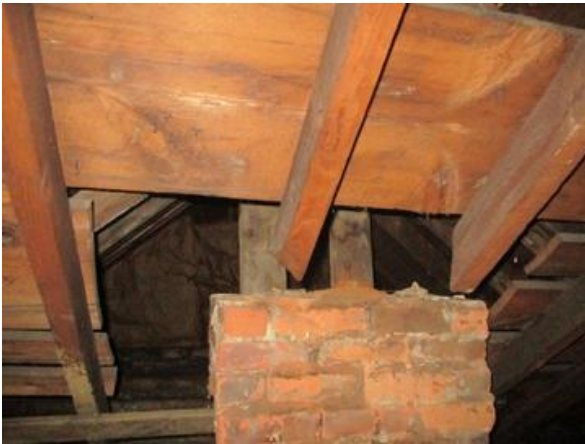
08/31/2020 One or more roof rafters it not properly supported or fastened. This could compromise the roof structure. Recommend licensed contractor repair as needed.

Rafter not fastened

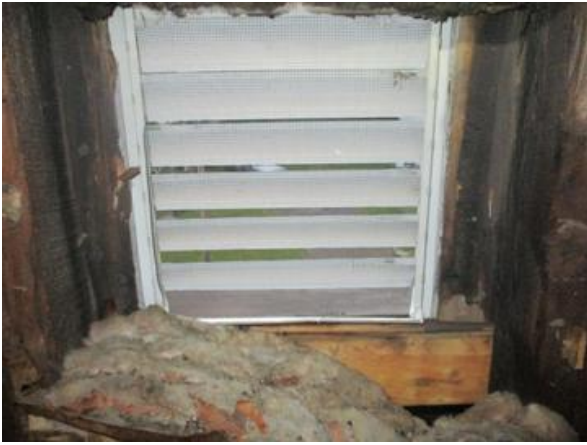
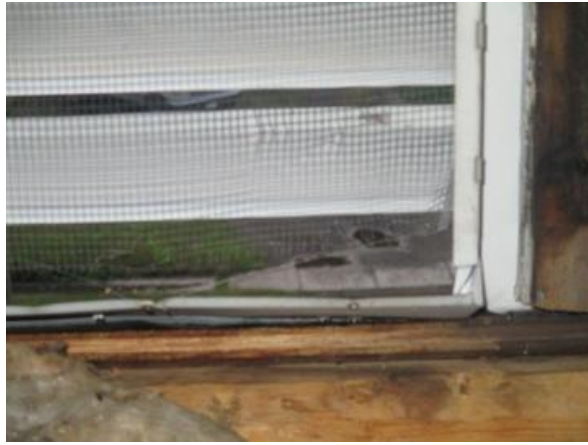
08/31/2020 Gable vent screen damaged. This may allow intrusion of insects and vermin. Recommend licensed contractor repair as needed.

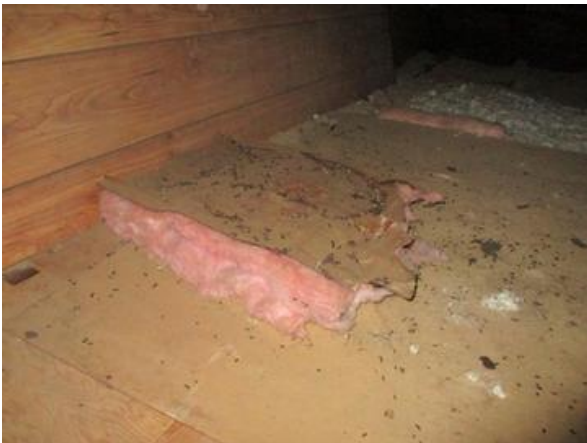
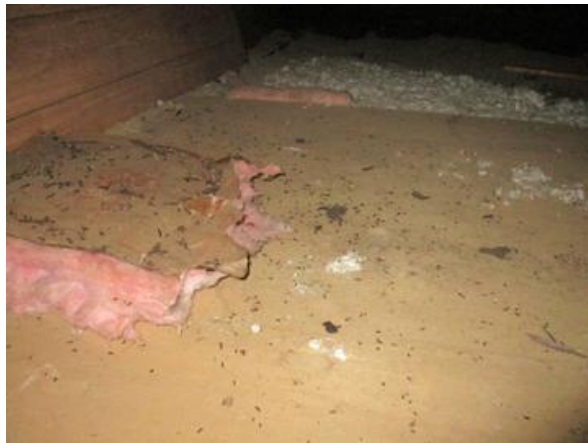
08/31/2020 Animal feces noted in attic space. Vermin could disturb insulation, damaged electrical lines. Recommend licensed exterminator evaluate and advise.

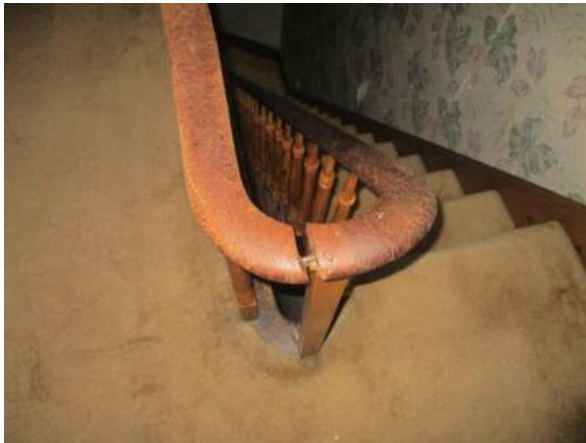
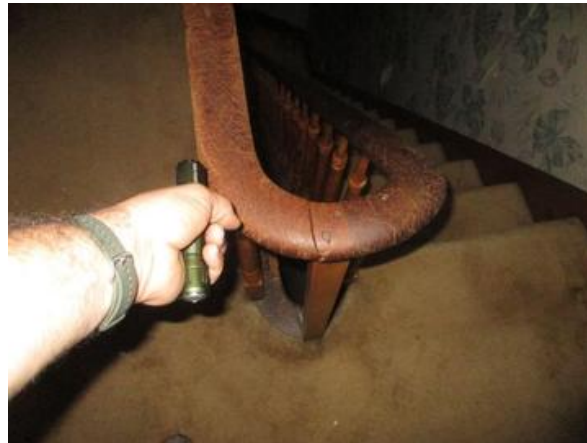
One or more stair handrails are not properly fastened to structure. If a fall were to occur this will not adequately support a person's weight and prevent a potential injury. Recommend qualified contractor repair as needed.

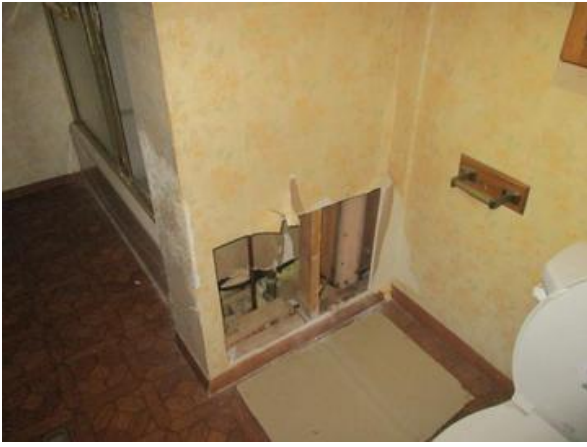
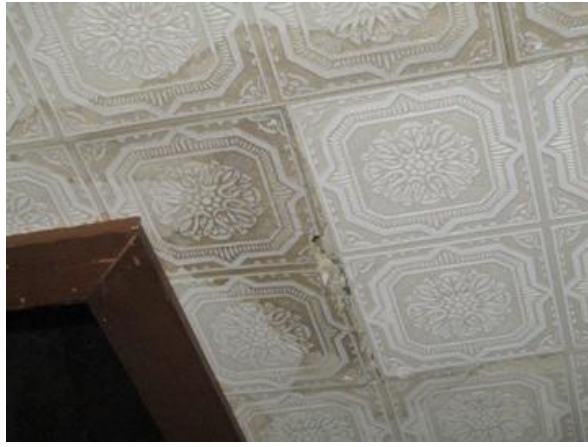
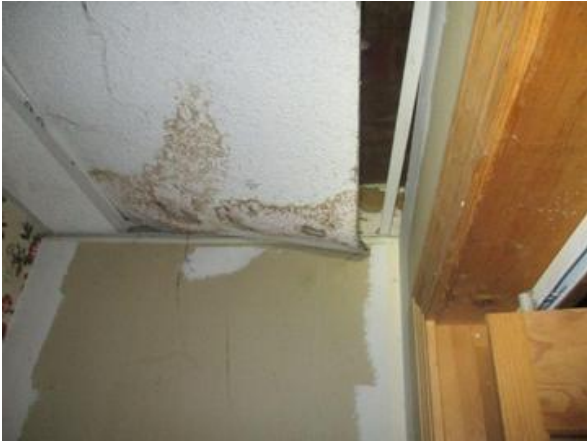
Large holes noted in wall/ceiling coverings. Recommend qualified contractor repair as necessary.

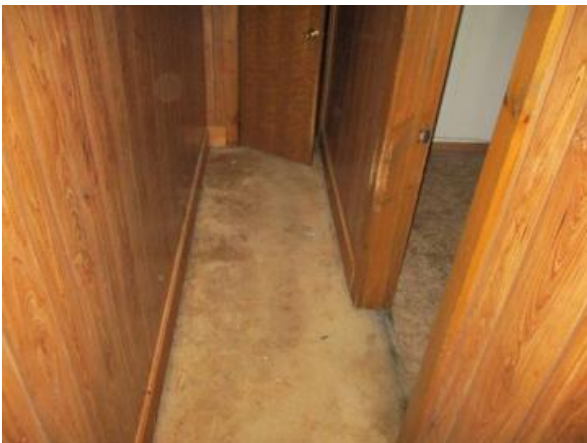
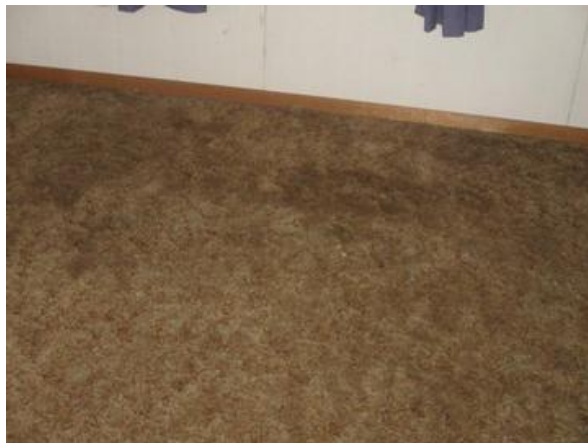
08/31/2020 Flooring throughout the house is deteriorated, showing signs of animal staining in multiple areas. All flooring needs repaired and/or replaced throughout the home. Recommend licensed contractor repair or replace as needed.

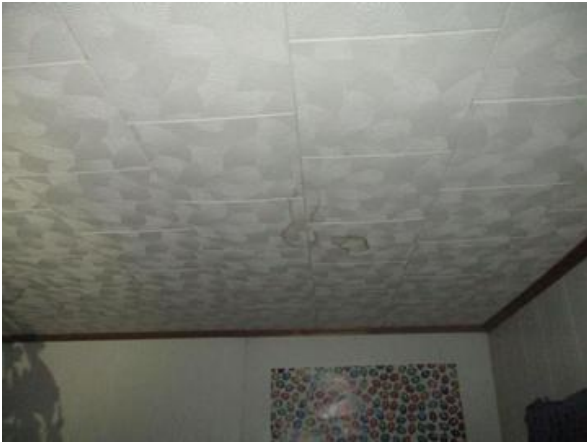
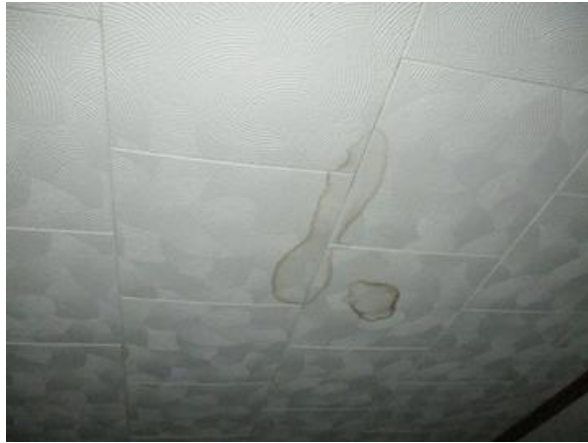
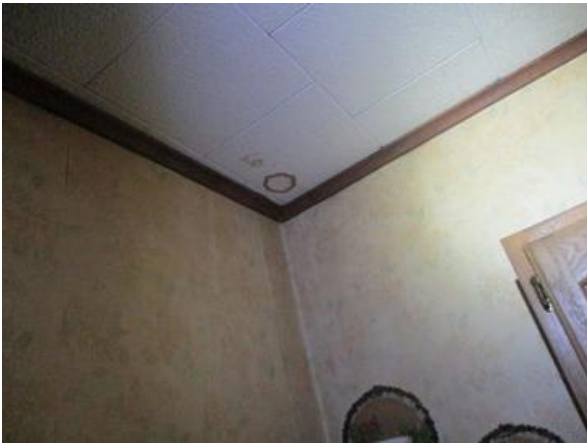
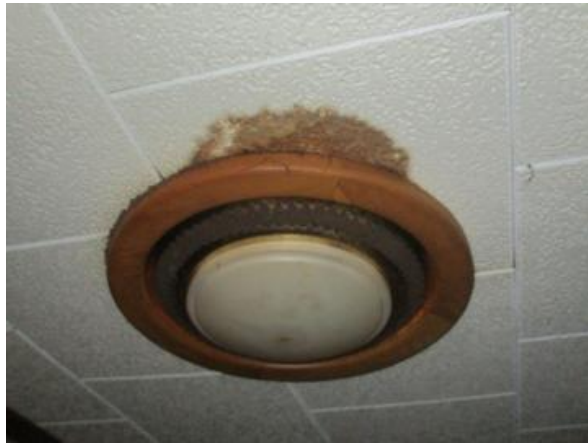
08/31/2020 Ceiling shows signs of old inactive water intrusion. Moisture meter test showed 0% moisture content. Staining likely occurred prior to metal roof installation.

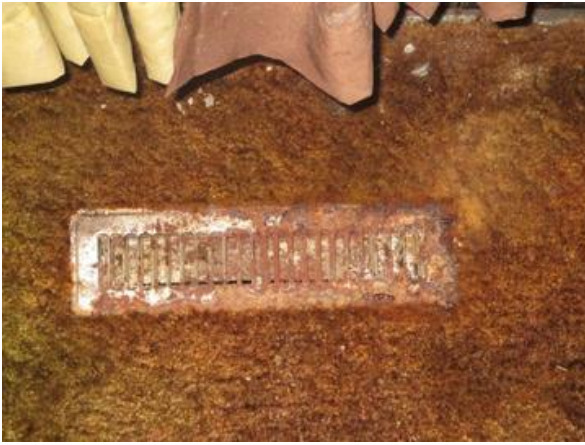
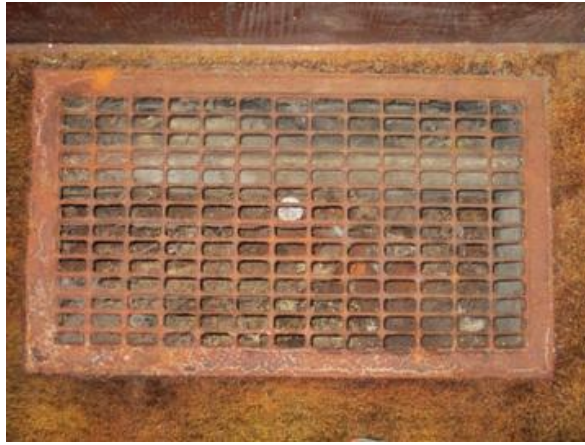
08/31/2020 One or more floor heat registers is deteriorated. This could fail if stepped on resulting in injury. Recommend licensed contractor repair or replace as needed.

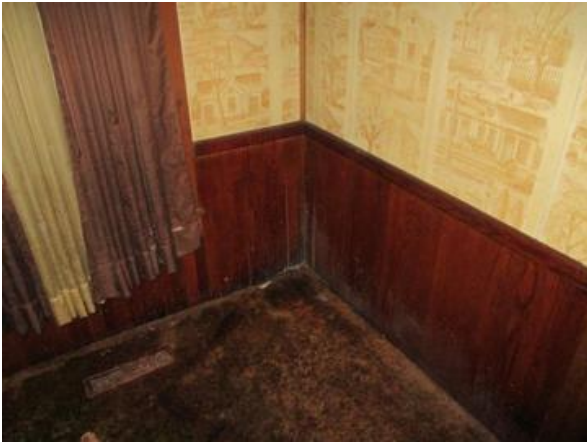
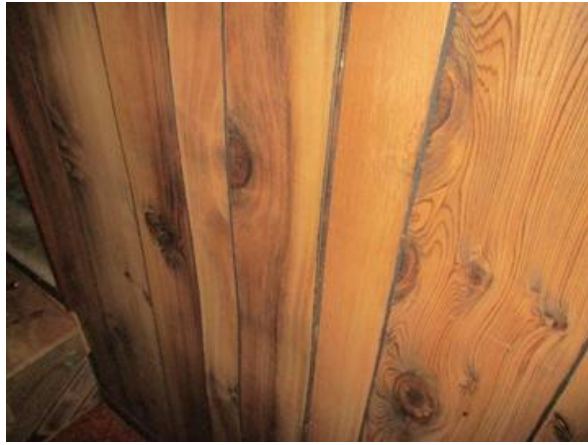
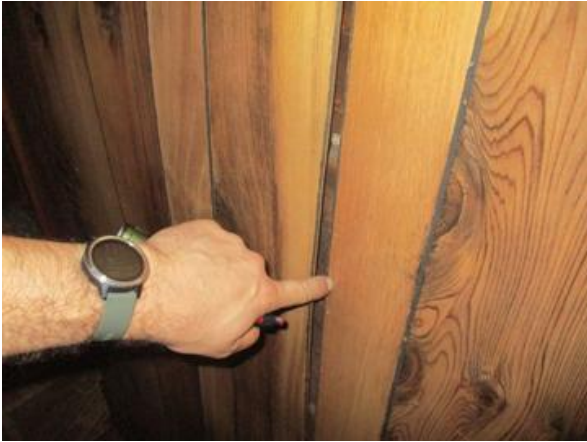
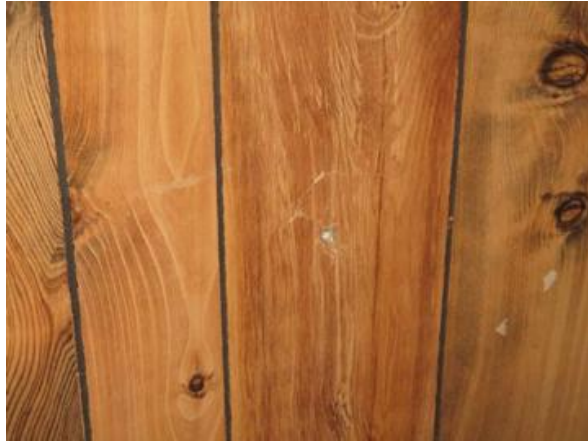
Wall paneling in one or more areas is loose and bulging. Some areas appear to be damaged from moisture, while others appear to have loose or missing fasteners. Recommend licensed contractor repair or replace as needed.

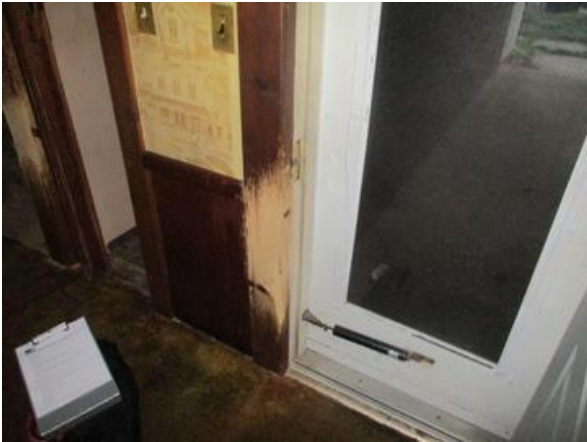
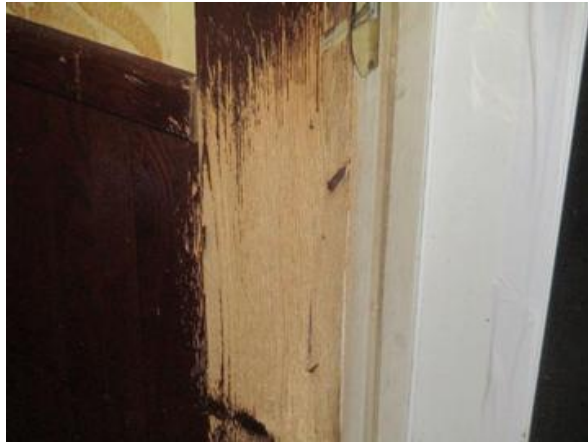
08/31/2020 Door trim damaged in one or more areas, likely due to animal scratching. Cosmetic issue, recommend licensed contractor repair or replace as needed.

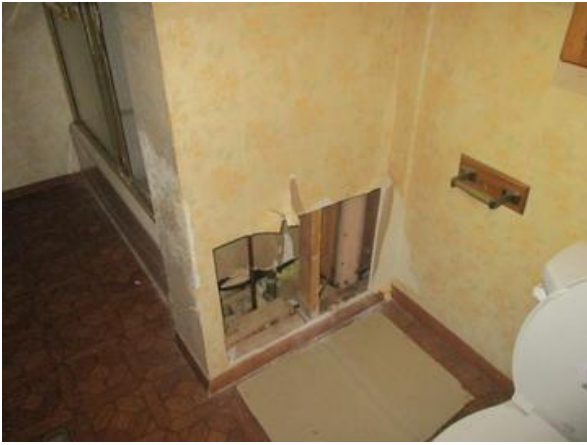
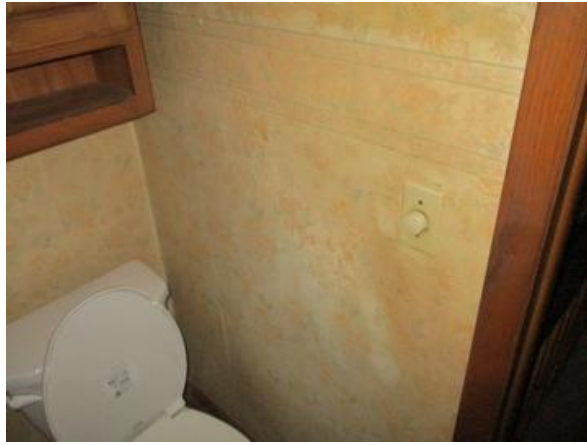
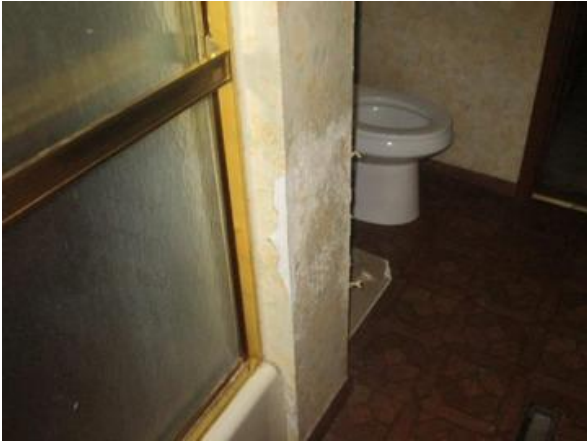
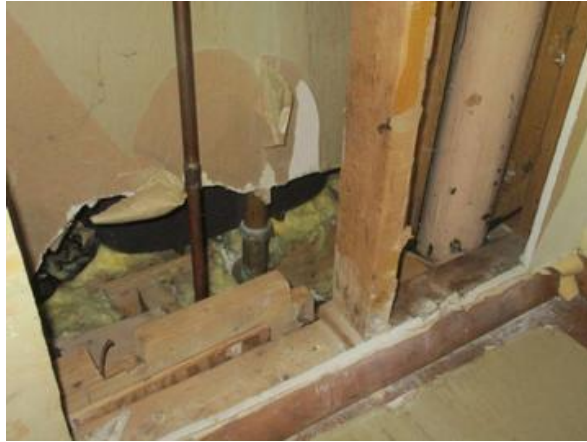
08/31/2020 Wall damaged or deteriorated in one or more areas. Recommend licensed contractor repair or replace as needed.

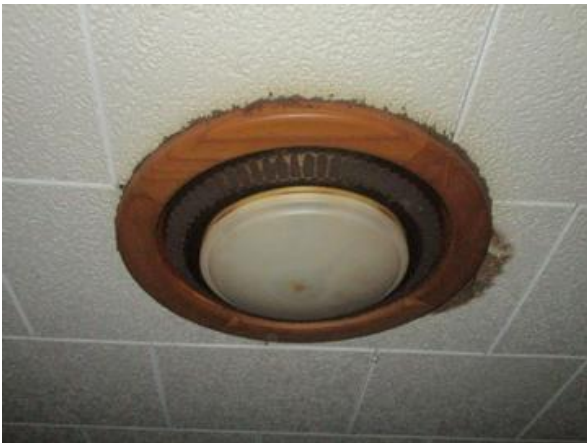
08/31/2020 Recommend cleaning exhaust fan. This will allow proper extraction of moist air aiding in the prevention of mold and mildew.

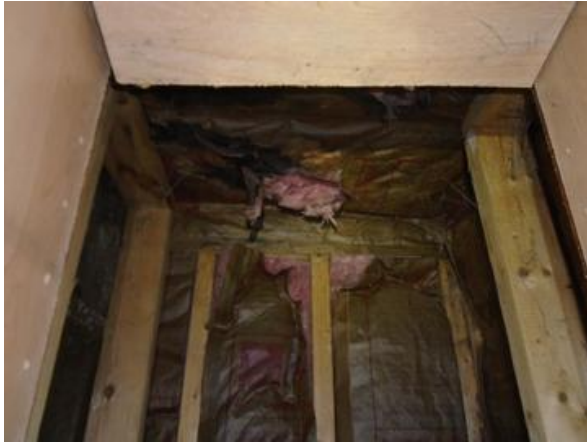
Installed cabinet is broken with no back panel allowing access to wall structure. Possibly mold like substance noted in unfinished area behind cabinet. Recommend qualified mold abatement professional evaluate and advise.

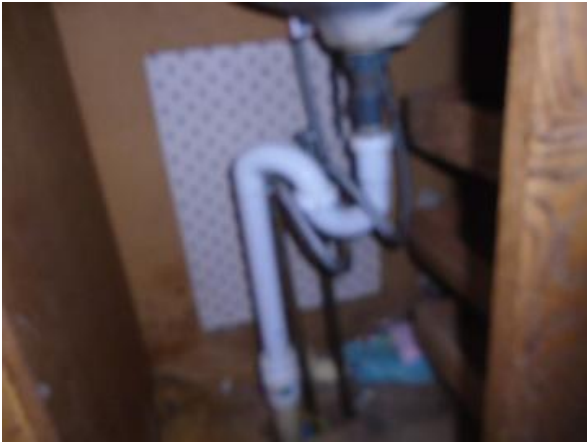
"S-trap" noted under sink. The reason "S traps" aren't industry standard is because they have the potential to suck, or siphon, water out of the trap as the water flows down the drain and allow sewer gas into living space. Recommend qualified plumber install "P-trap".

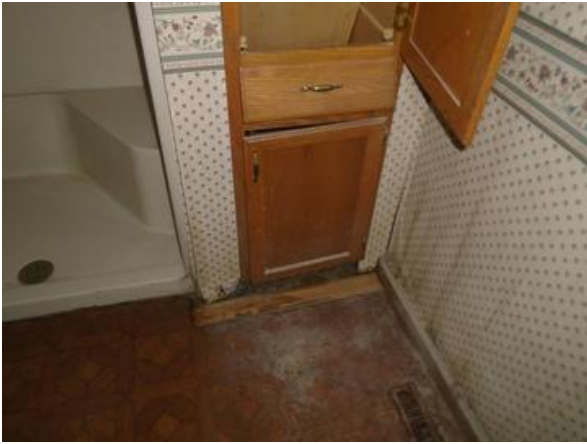
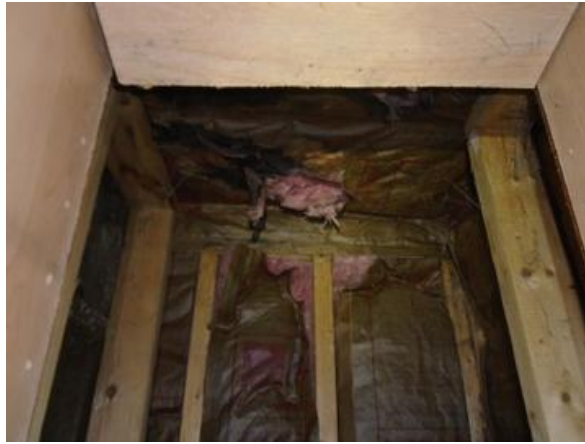
08/29/2020 Installed cabinet is broken with no back panel allowing access to wall structure. Recommend qualified contractor evaluate and repair as needed.

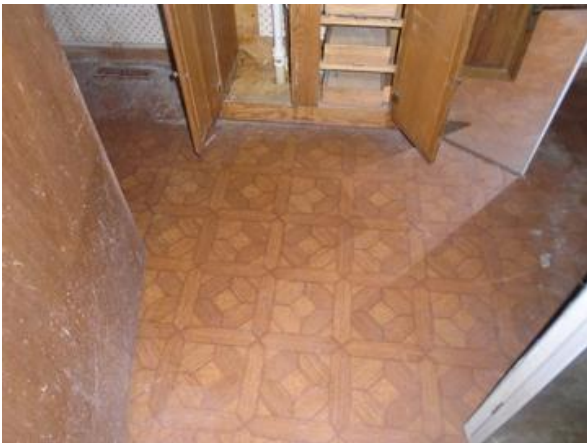
08/29/2020 Flooring in poor condition. Recommend qualified contractor evaluate and repair or replace as needed.

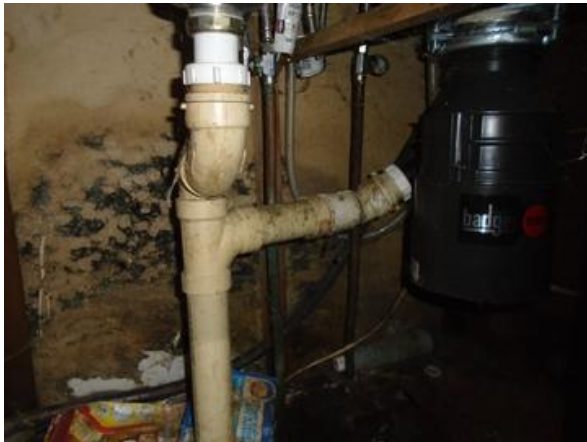
08/29/2020 No trap located under sink. This will allow sewer gasses into home. Recommend qualified plumber evaluate and repair.

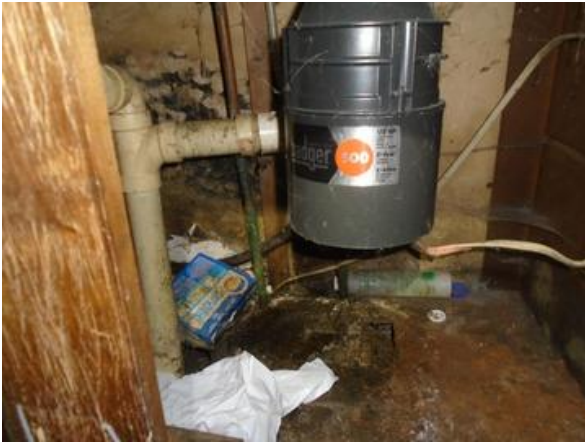
08/29/2020 Mold like substance noted under kitchen sink. Recommend qualified mold abatement professional evaluate and advise further course of action.

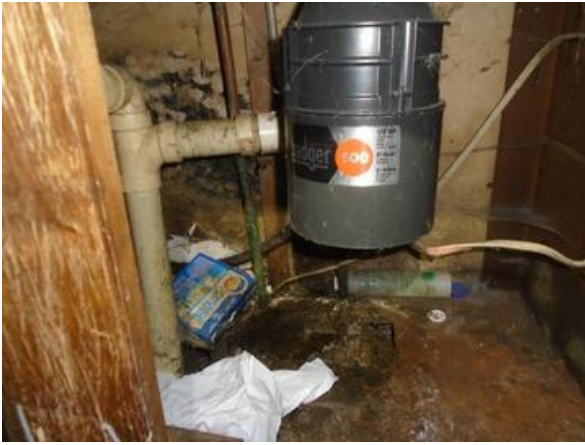
Active leak noted under sink. Recommend qualified plumber evaluate and repair as needed to prevent further deterioration of cabinets and structure.

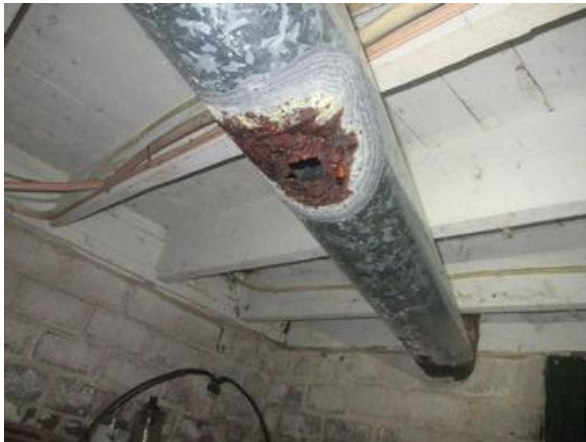
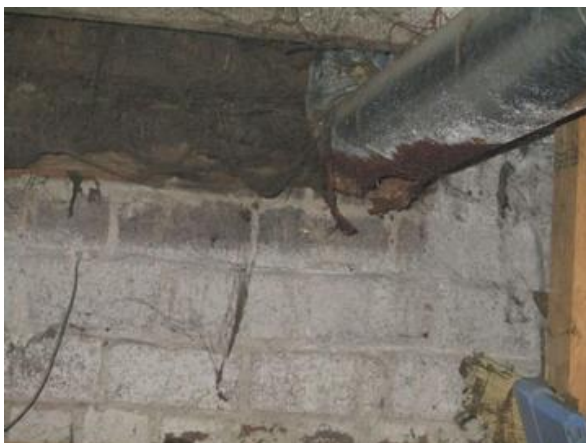
08/31/2020 Heating system duct work is severely deteriorated in one or more areas. Recommend licensed contractor replace or repair as needed.

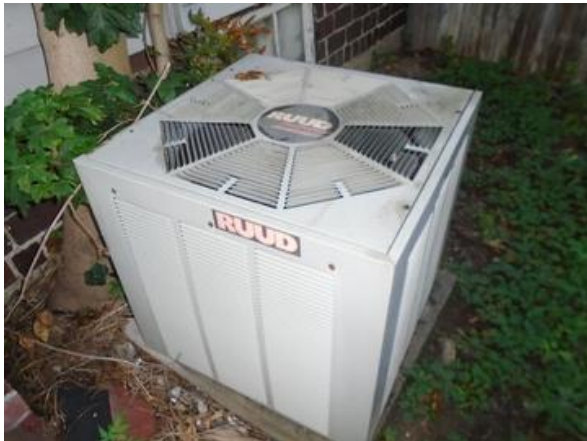
08/29/2020 Shrubbery inhibits a good air flow for proper operation. Recommend keeping shrubbery away from air intakes.

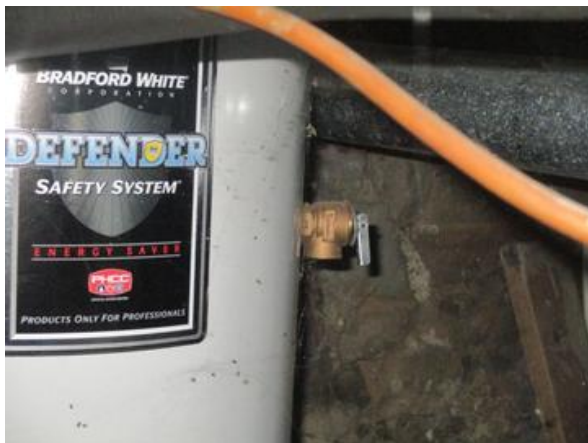
08/31/2020 Drain line is missing. Recommend having a licensed plumber install a drain line extending to within 6" from the floor, or routed so as to drain outside.

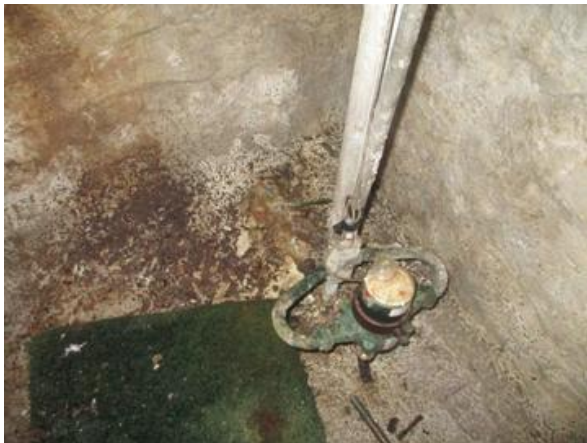
Some, most, or all of the water supply pipes in this structure are made of galvanized steel. Based on the age of this structure, corrosion, leaks, and/or the results of a "functional flow test" performed during the inspection, some or all of these pipes appear to have exceeded their estimated useful life of 40 to 60 years. During a functional flow test, multiple fixtures are run simultaneously to determine if the flow is adequate. For example, if the shower flow decreases substantially when the toilet is flushed. Internal corrosion and rust can reduce the inside diameter of these pipes over time, resulting in reduced flow and leaks. A qualified plumber should evaluate and replace supply pipes and fittings as necessary.

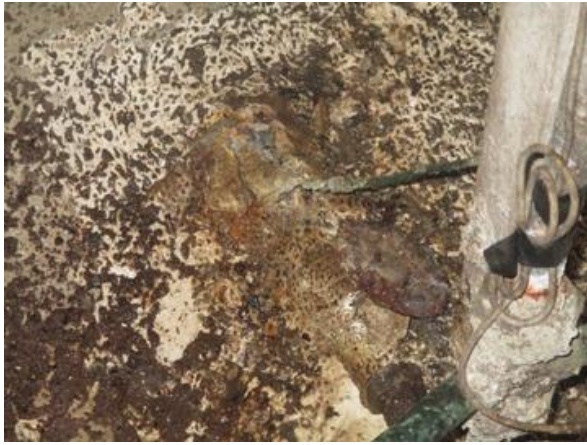
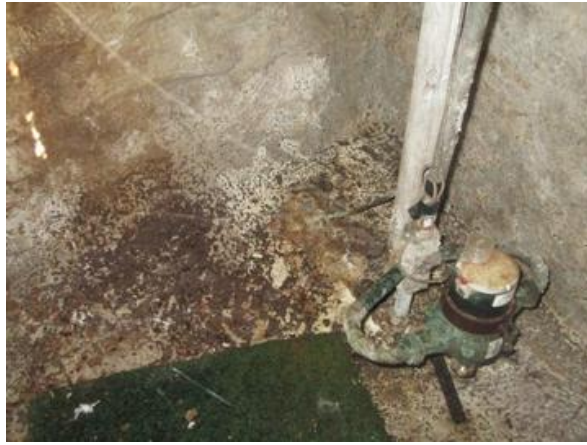
One or more active leaks were found in supply pipes or fittings. A qualified plumber should evaluate and repair as necessary.

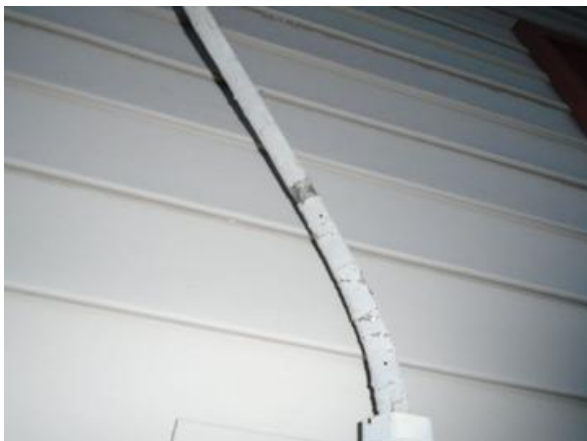
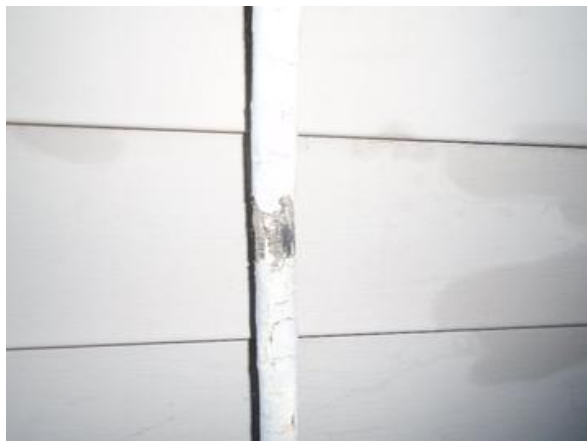
Service entry cable on exterior is deteriorated. This can lead to water penetration into the meter socket as well as the electrical panel causing sparks, arcs, or fires. Recommend qualified electrician evaluate and repair as needed.

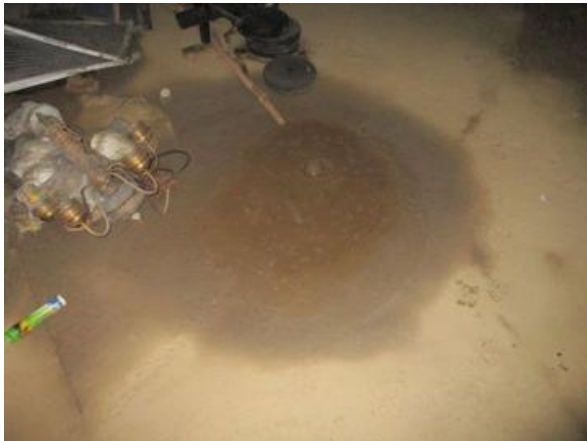
Extensive signs of moisture on basement walls and floor. Recommend gutters be installed/repared on house and grade be improved to keep water away from foundation. Contact a qualified contractor to determine proper method of sealing the basement from further deterioration.

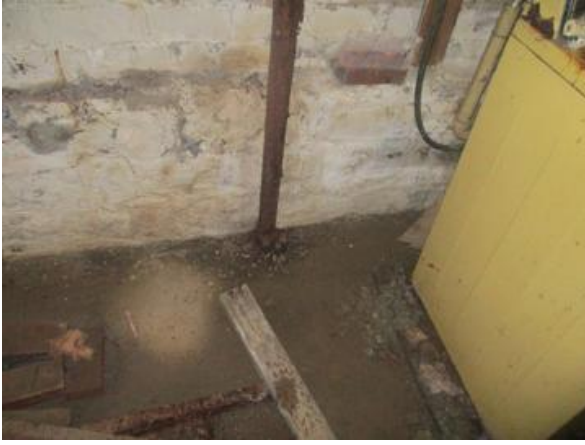
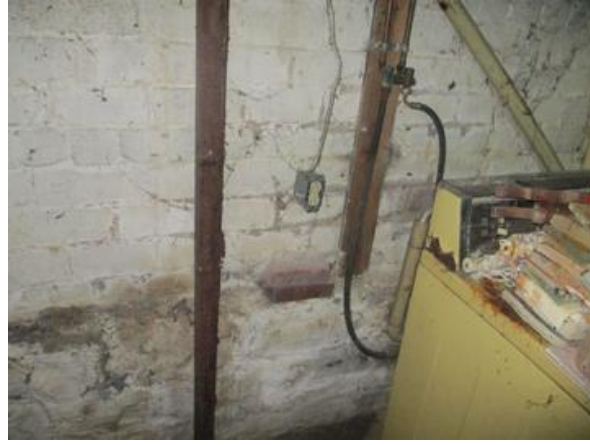
One or more steel support posts are rusted and not properly secured to the floor or beam. The rust could weaken the post. While not being properly secured could allow the post to shift. Recommend licensed contractor evaluate and repair as needed.
