Client

Catt County Land Bank
215 S Barry
Olean, NY 14760
HIN™: 147602464
Email:
Inspection Date: 08-27-2020

Eagle Eye Home Inspectors, LLC
Shawn Wing
1523 OLEAN PORTVILLE RD
OLEAN, NY 14760
Phone: (716) 307-0514
E-Mail: info@eehomeinspectors.com

Welcome and thank you for choosing Eagle Eye Home Inspectors. This report is designed to be as thorough as possible, but also clear and concise. This is not a mold inspection. This is not a code inspection. If you have any questions please call us at (716) 307-0514 or (716) 378-8855

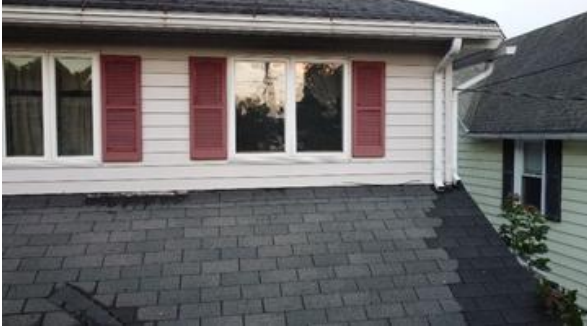
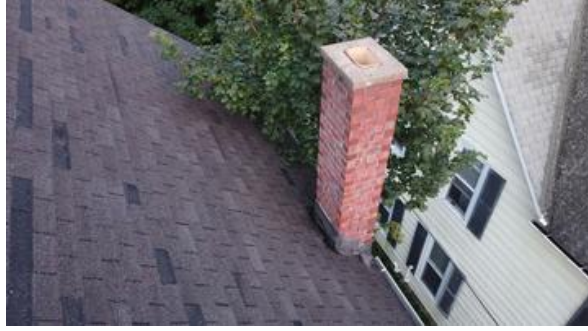
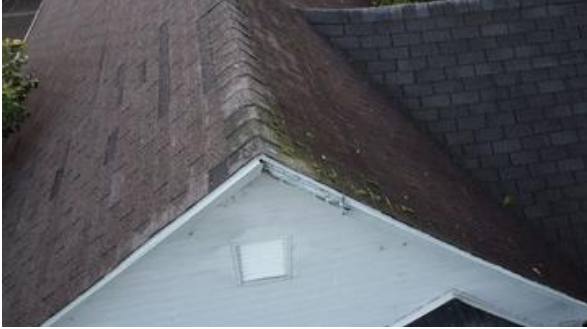
08/29/2020 The roof surface material is beyond or at the end of its service life and needs replacing now. I recommend you consult with a qualified roofing contractor to determine replacement options and costs.

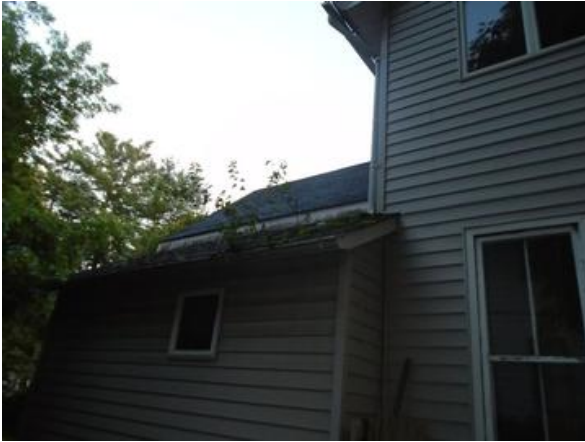
08/29/2020 Gutters are installed but are not functioning due to being broken, sagging, filled with debris, and having improper pitch. Proper functioning gutters are essential to keeping water away from the foundation to prevent water infiltration into the home. Recommend a qualified contractor replace gutters, downspouts, and extensions that are at least 6 ft. away from foundation wall.

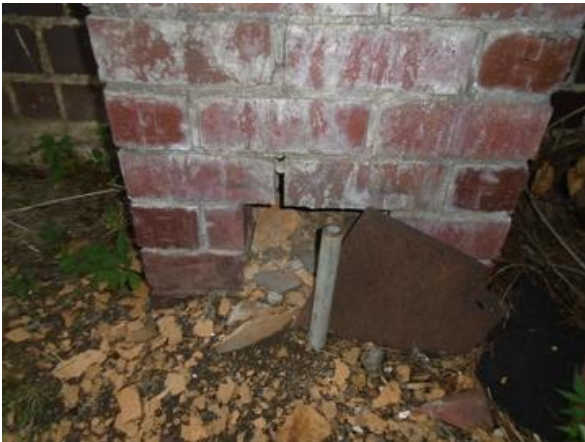
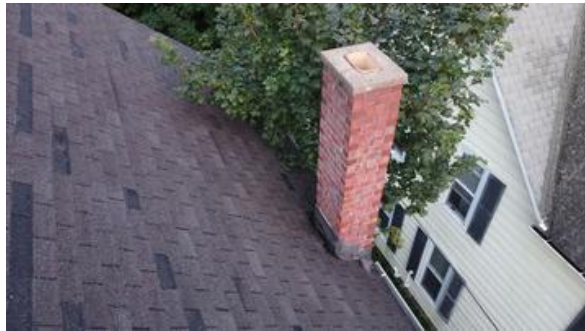
Multiple areas of the chimney have noted defects. Chimney crown is cracked, multiple areas have deteriorated or missing mortar, no cricket installed on roof to divert water away from chimney, flashing where roof dies into chimney is deteriorated and has roofing sealant indicating an prior leak, and flue is clearly damaged and pieces are falling out of exterior cleanout. Recommend qualified mason evaluate and repair as needed.

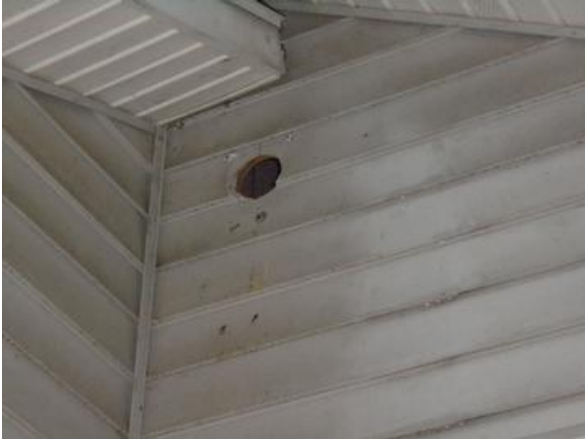
08/29/2020 One or more unsealed exterior penetrations. This can lead to water to vermin intrusion. Recommend qualified contractor evaluate and repair as needed.

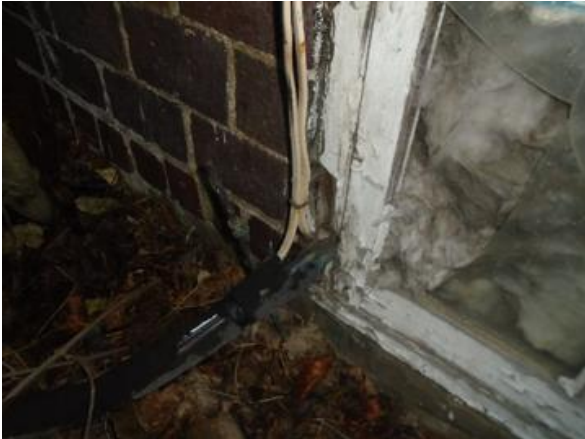
08/29/2020 Air conditioner coolant lines penetrating the foundation wall are not sealed. This will allow water intrusion resulting in deterioration of the wall over time. Recommend a licensed contractor repair as needed.

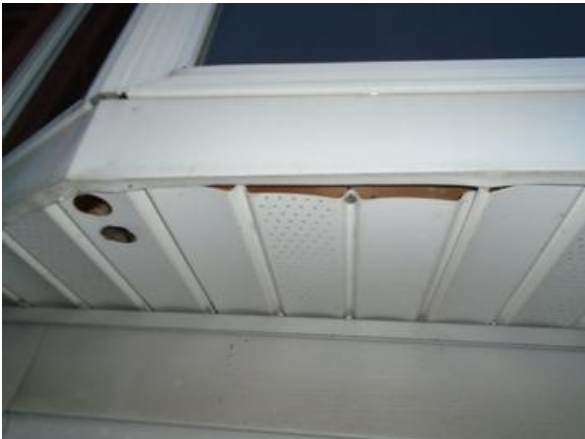
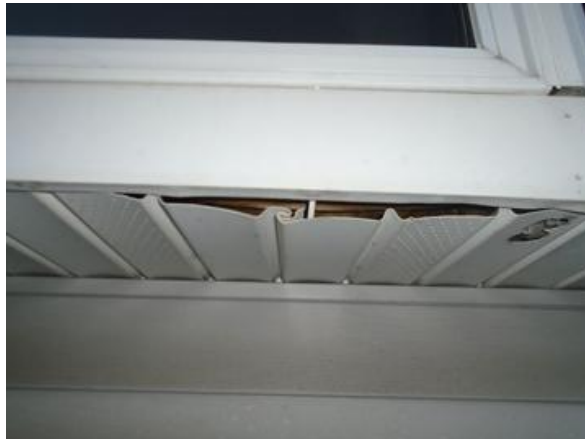
08/29/2020 One or more areas of vinyl trim are loose, damaged, or missing. Recommend qualified contractor evaluate and repair as needed.

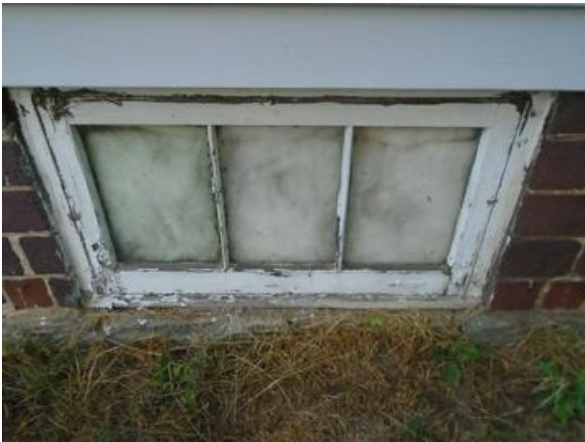
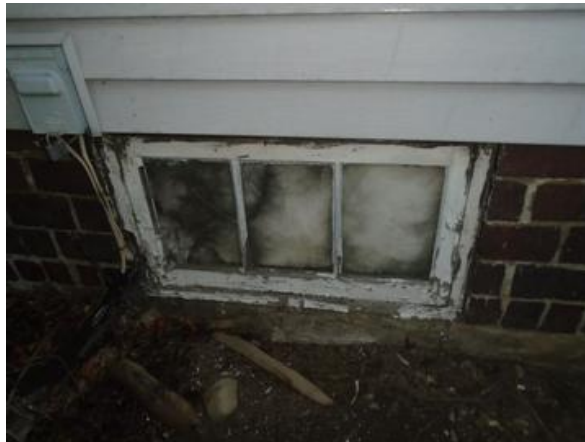
08/29/2020 Window well installation recommended on all basement windows. This will keep pooling water and drifting snow away from windows and foundation. This will also help to prevent water intrusion and aid in drainage.

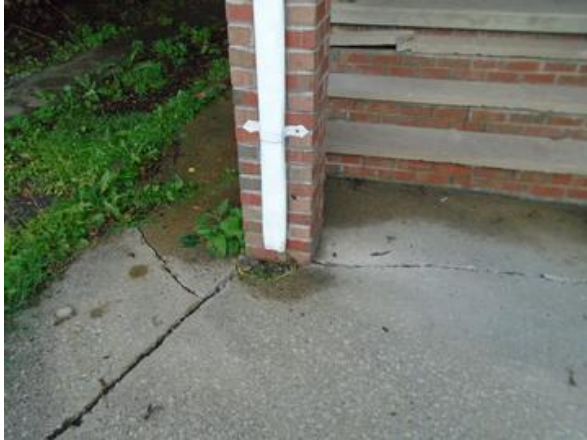
08/29/2020 Front sidewalk and walkway leading to front porch deteriorated. This can be a tripping hazard possibly resulting in personal injury. Recommend licensed contractor repair as needed.

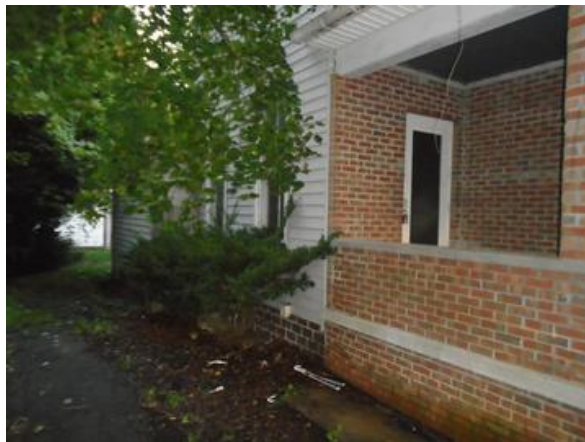
08/29/2020 Trees and shrubs are in contact with siding and overhanging roof. This allows the shrubs to rub against the house creating friction damage as well as not allowing the siding and roof to dry quickly after rain fall. This can also be a conduit for vermin and insects accessing the home. Recommend pruning or moving trees and shrubs so there's at least a one foot gap between shrubs and siding no no trees overhanging roof.

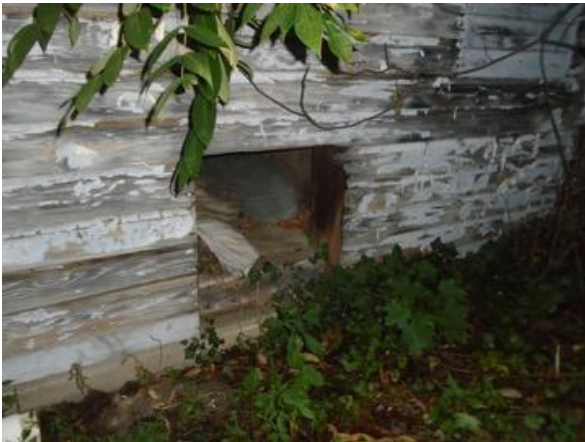
08/29/2020 Large unsecured hole noted in side of garage. This may be access for possible illegal occupation of structure or vermin access. Recommend qualified contractor evaluate and repair as needed.

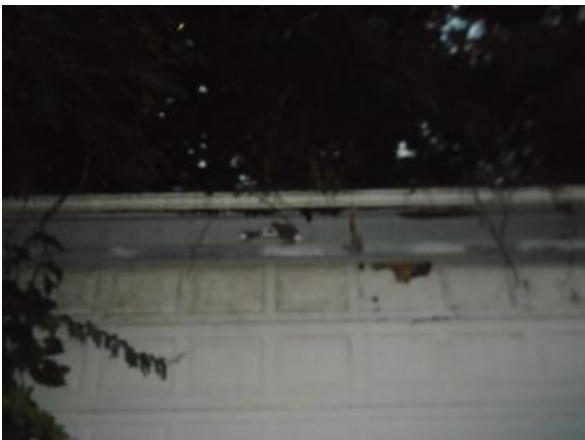
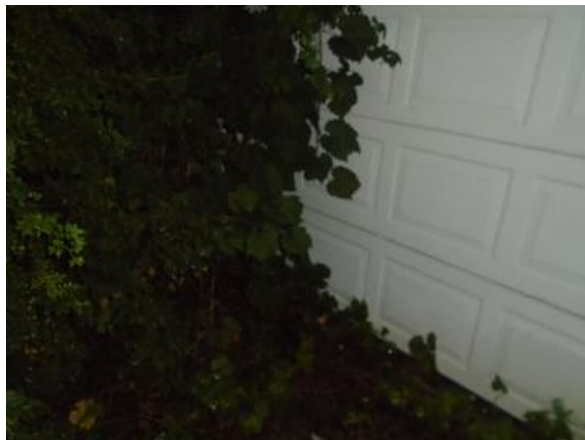
08/29/2020 Trees and shrubs are in contact with siding and overhanging roof. This allows the shrubs to rub against the house creating friction damage as well as not allowing the siding and roof to dry quickly after rain fall. This can also be a conduit for vermin and insects accessing the home. Recommend pruning or moving trees and shrubs so there's at least a one foot gap between shrubs and siding no no trees overhanging roof.

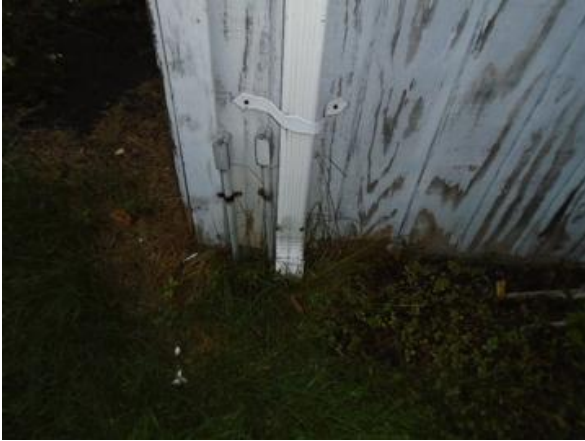
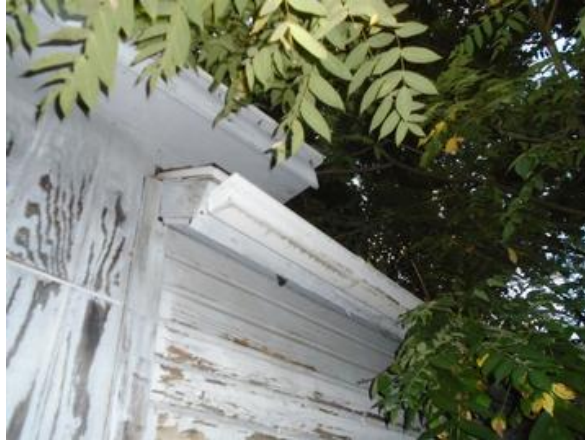
Gutters are installed but are not functioning due to being broken, sagging, filled with debris, and having improper pitch. Proper functioning gutters are essential to keeping water away from the foundation to prevent water infiltration into the home. Recommend a qualified contractor replace gutters, downspouts, and extensions that are at least 6 ft. away from foundation wall.

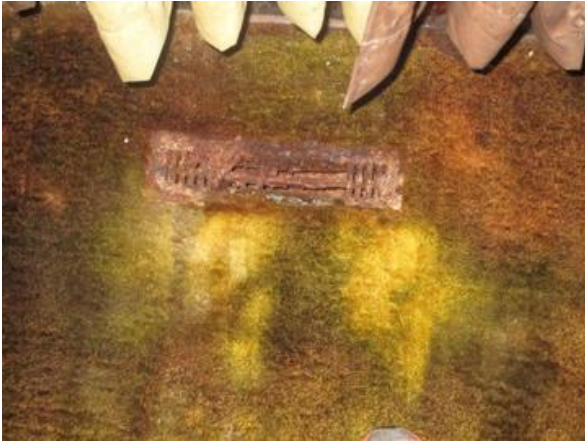
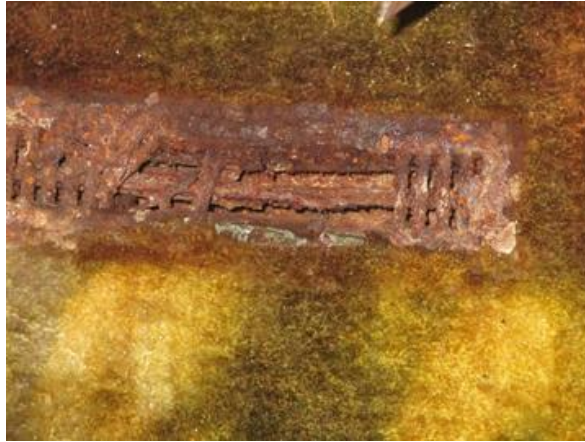
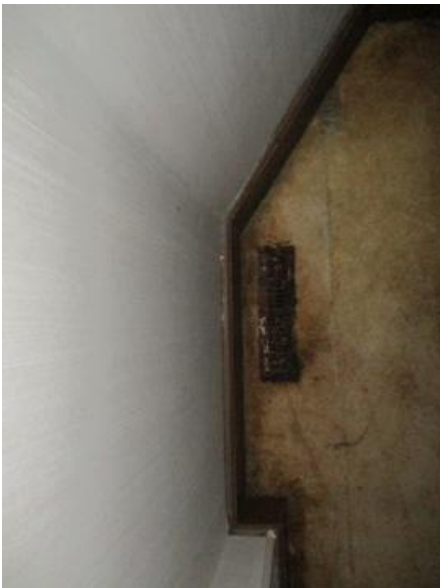
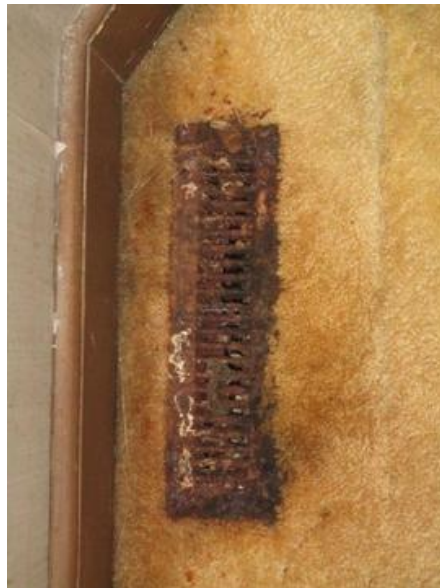
08/31/2020 One or more floor heat registers is deteriorated. This could fail if stepped on resulting in injury. Recommend licensed contractor repair or replace as needed.

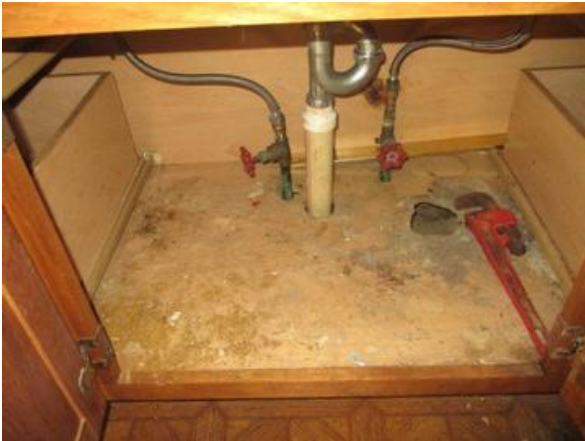
08/31/2020 Vanity base shows signs of previous water damage. Recommend licensed contractor repair or replace as needed.

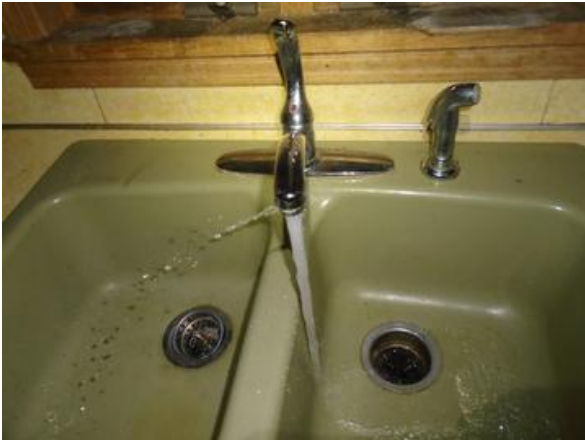
The porcelain finish on the kitchen sink is chipped and the steel underneath is rusting. This can lead to leaks and water damage. Recommend qualified contractor evaluate and repair.

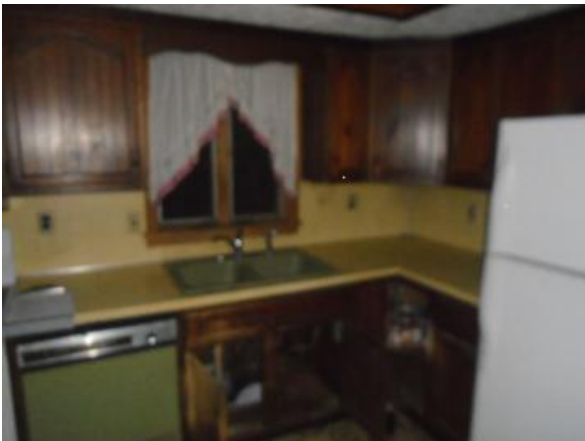
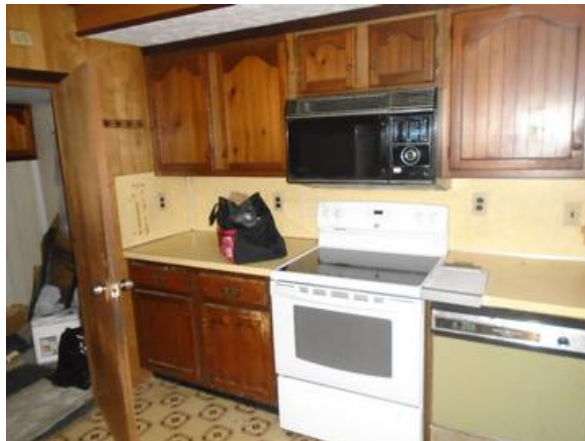
08/29/2020 All upper and lower cabinets are in poor condition. Recommend qualified contractor evaluate and repair or replace as needed.

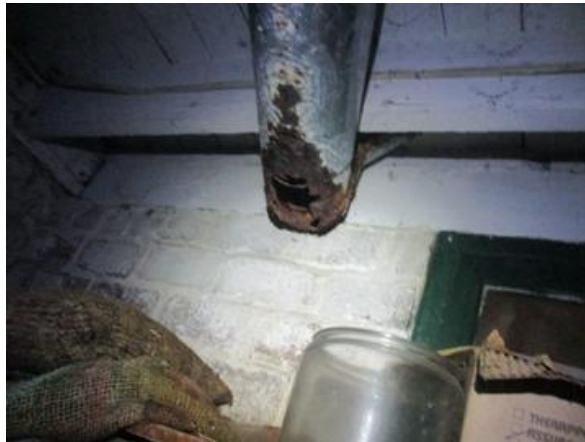
08/31/2020 Heating system duct work is severely deteriorated in one or more areas. Recommend licensed contractor replace or repair as needed.

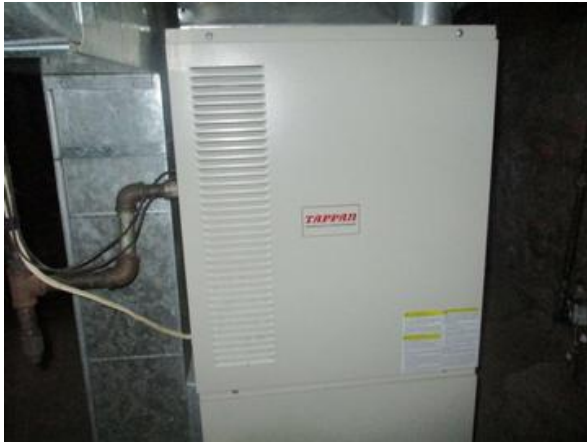
08/31/2020 Furnace was not inspected on the day of the inspection due to service not being on. Inspector will return at a later time to complete the inspection.

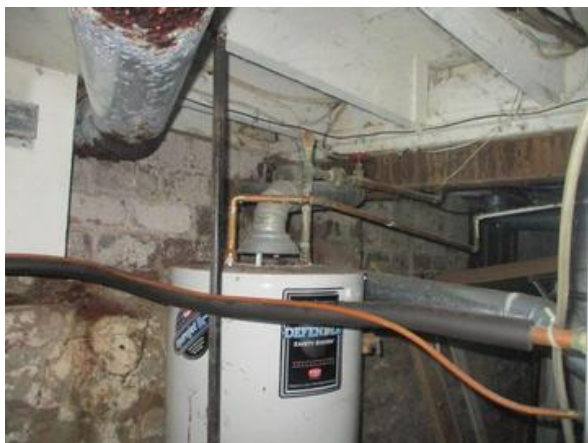
08/31/2020 Water heater not tested on the day of the inspection. The estimated useful life of a gas water heater is eight to 12 years. Because of its age this water heater may need replacing at any time.

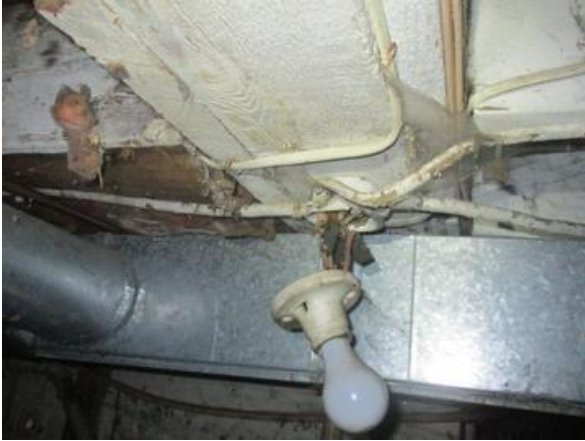
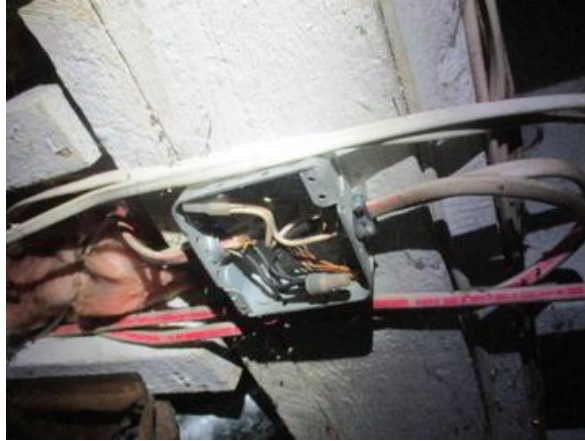
08/31/2020

One or more electrical/junction boxes throughout the entire home are missing covers. This can lead to shocks or fires. Recommend qualified contractor evaluate and repair as needed.

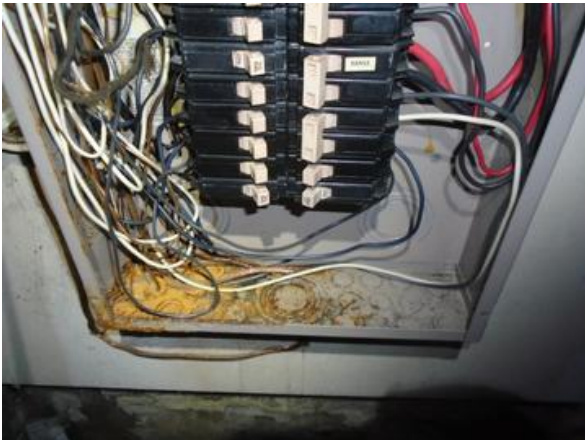
08/29/2020

Extensive rust noted in Electric Service Panel. This can be hazardous. Recommend a licensed electrician repair or replace as necessary.
